**Project Name:** Arun DC Slindon Pond Scheme Church Hill Slindon WestSussex

**Project Date:** 03/12/2020

**Inspection Standard:** MSCC5 Sewers & Drainage GB (SRM5 Scoring)

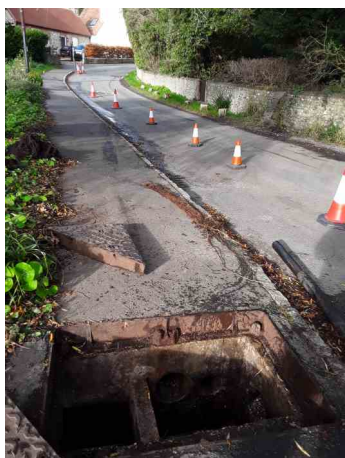
Catch pit 1 looking up Church Hill

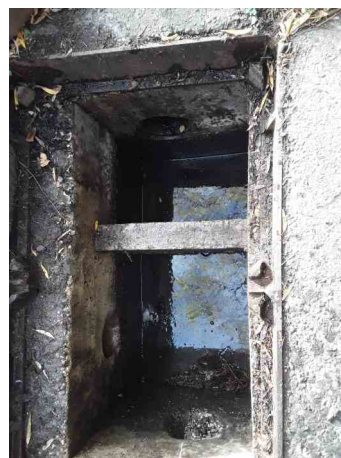
Catch pit 1

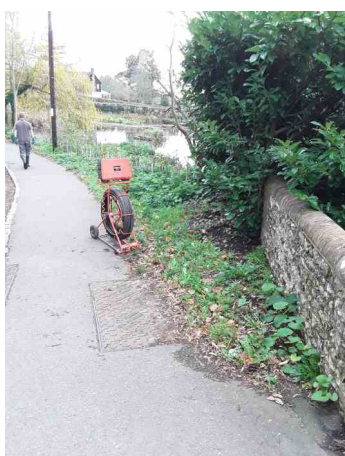
Catch pit 2 Looking towards pond

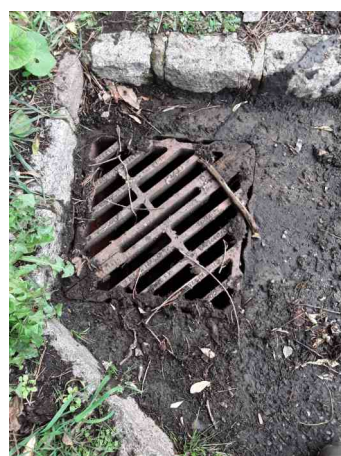
Gully 3

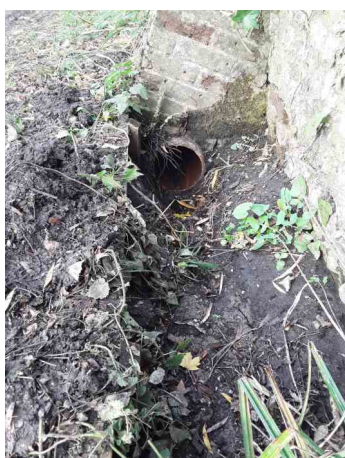
Open pipe in Ditch upstream to Gully 3

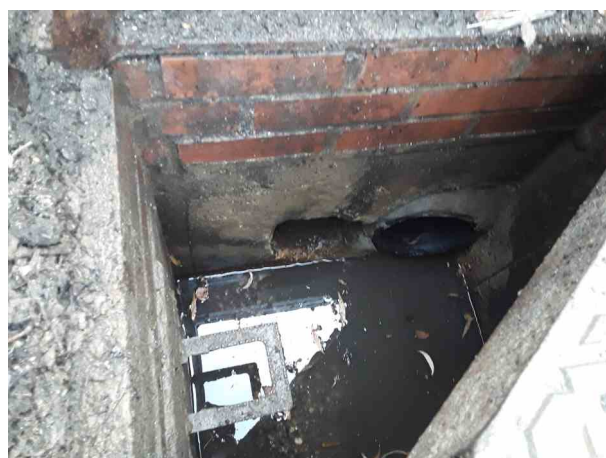
Overflow and Lateral to Gully 2 inside Catch pit 1

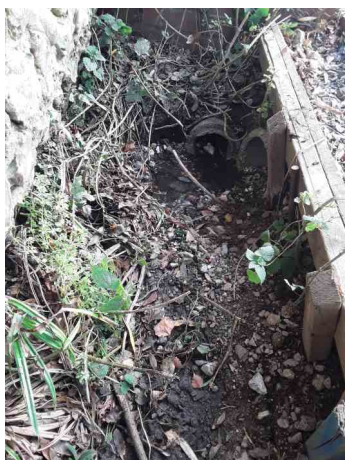
Pipe from Ditch beneath road to CP 1 and Lateral 1 pipe top of screen

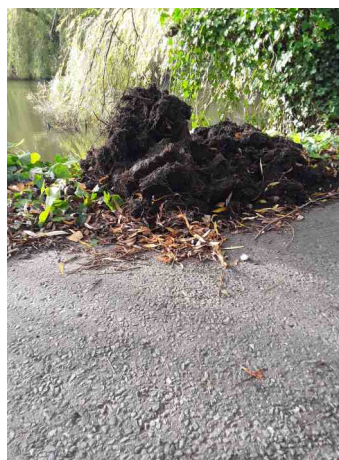
Root mass from Gullies 1 & 2

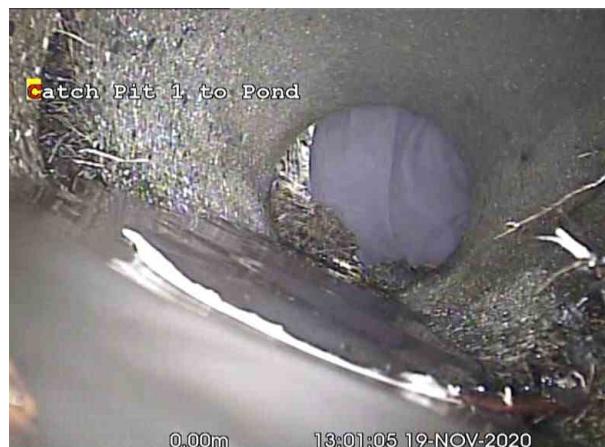
1X\_c17edd41-0b1a-4087-b8d9-ff70b5bb1a1c\_20201203\_1729  
00\_625.jpg, 00:00:20, 0.80 m

| Scale: | 1:50 | Position [m] | Code | Observation | MPEG | Photo | Grade |
|---|---|---|---|---|---|---|---|
| | | 0.80 | RMJ | Roots, mass at joint, 5% cross-sectional area loss | 00:00:20 | SMH<br>1X_c17edd<br>41-0b1a-4 | 3 |

Roots, mass at joint, 5% cross-sectional area loss

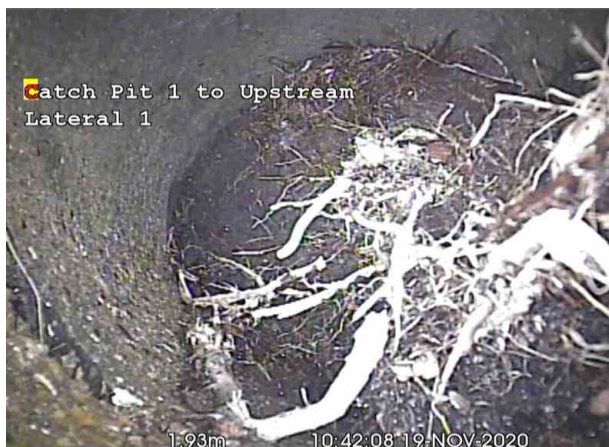
1X\_bc5bd890-02cf-4ef9-8c54-76a8d40f56e4\_20201203\_173436\_005.jpg, 00:00:35, 1.93 m

Roots, mass, 100% cross-sectional area loss, Root Mass on 90 Degree bend beneath path, also large hole in pipe caused by ingress

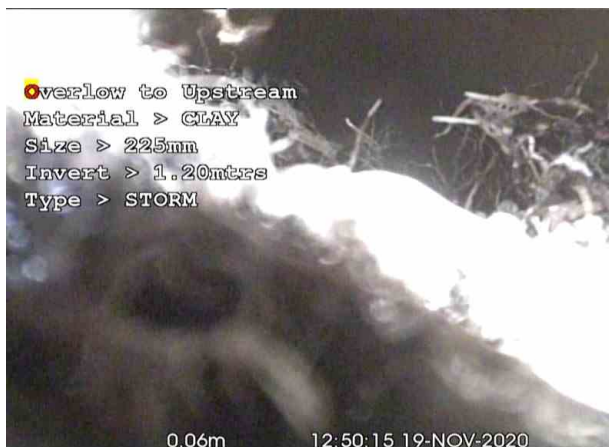
1X\_e8a8d98b-812a-44c2-bd41-f2a270ab358d\_20201203\_173845\_878.jpg, 00:00:02, 0.00 m

Roots, mass, 50% cross-sectional area loss, start

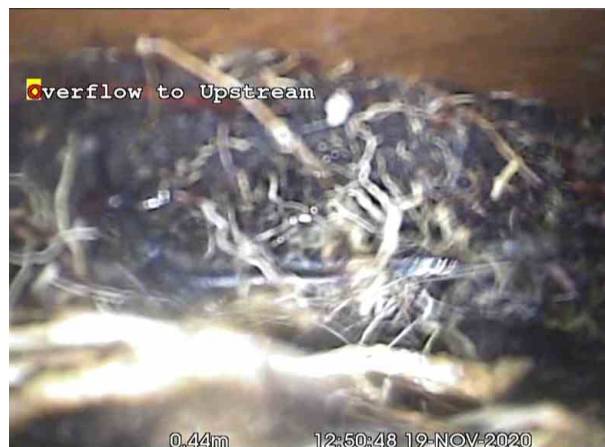
1X\_3baff8c0-3865-47ec-9a6a-719f03c192f2\_20201203\_174024\_380.jpg, 00:00:35, 1.44 m

Hole in drain or sewer from 12 o'clock to 11 o'clock: Root mass on 90 degree bend Pipe missing (requires excavation)

Hole in drain or sewer from 12 o'clock to 11 o'clock, Root mass on 90 degree bend Pipe missing (requires excavation)

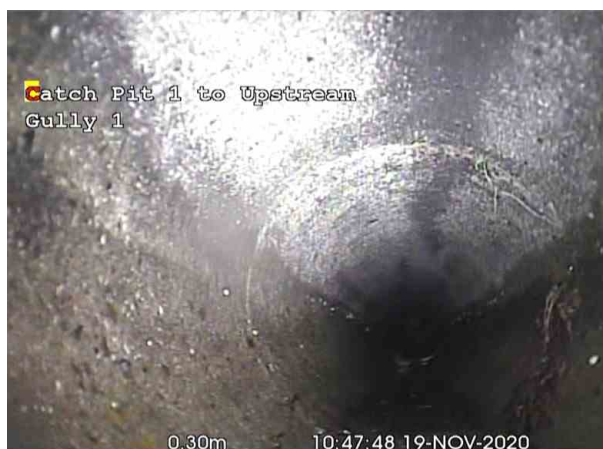
| Scale: | 1:50 | Position [m] | Code | Observation | MPEG | Photo | Grade |
|---|---|---|---|--|---|---|---|
| | | 0.30 | RTJ | Roots, tap at joint | 00:00:19 | Gully<br>1X_ed6d2<br>9a1-1dd0- | 4 |

Gully  
1X\_ed6d29a1-1dd0-49ec-9eb4-5e931f84b941\_20201203\_1743  
19\_723.jpg, 00:00:19, 0.30 m  
Roots, tap at joint

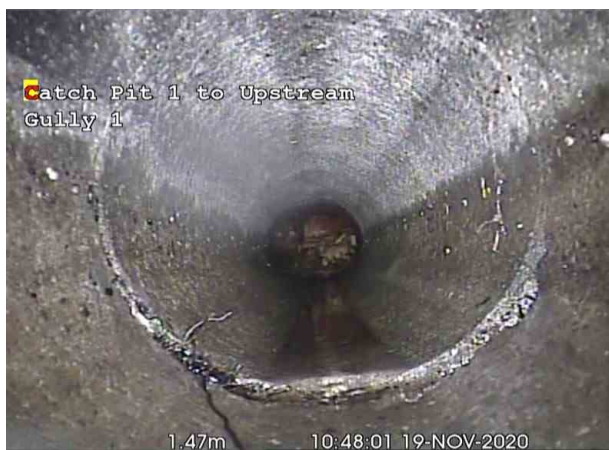
| Scale: | 1:50 | Position [m] | Code | Observation | MPEG | Photo | Grade |
|---|---|---|---|--|---|---|---|
| | | 1.47 | RFJ | Roots, fine at joint | 00:00:30 | Gully<br>1X_68019f<br>43-8102-4f | 2 |

Gully  
1X\_68019f43-8102-4f49-8fb5-05148a9f3052\_20201203\_17435  
7\_501.jpg, 00:00:30, 1.47 m  
Roots, fine at joint

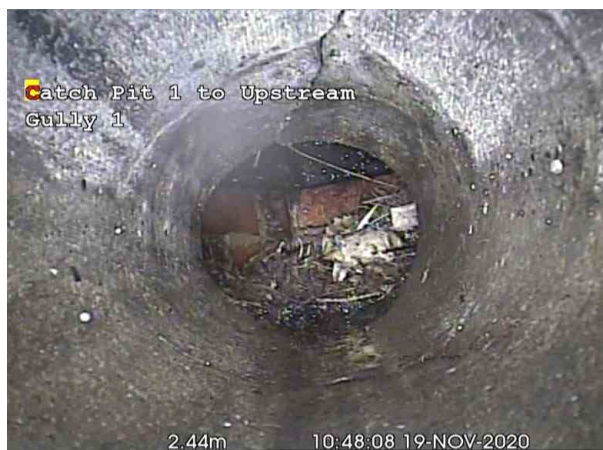
| Scale: | 1:50 | Position [m] | Code | Observation | MPEG | Photo | Grade |
|---|---|---|---|--|---|---|---|
| | | 2.44 | CM | Cracks, multiple from 12 o'clock to 11 o'clock | 00:00:38 | Gully<br>1X_6f9088<br>f9-0f72-4b | 3 / 2 |

Gully  
1X\_6f9088f9-0f72-4b65-b413-84591f1a3f42\_20201203\_174447  
\_210.jpg, 00:00:38, 2.44 m  
Cracks, multiple from 12 o'clock to 11 o'clock

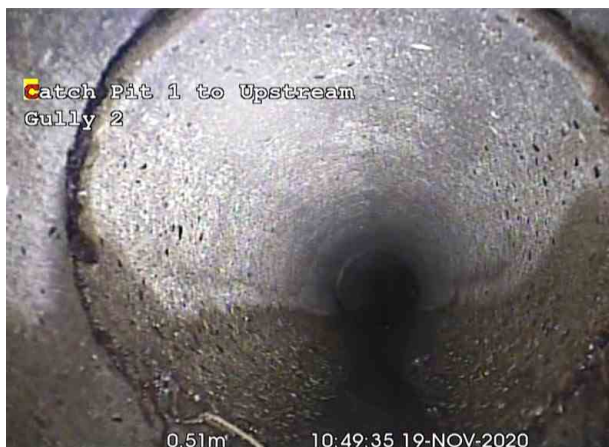
2X\_bba62c1f-a713-419b-be39-37a623986f26\_20201203\_174754\_932.jpg, 00:00:17, 0.50 m

Roots, mass at joint, 5% cross-sectional area loss: Now removed

Roots, mass at joint, 5% cross-sectional area loss, Now removed

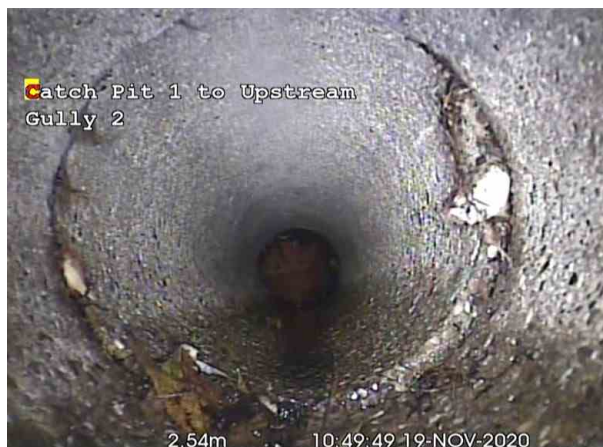
2X\_b076cf48-2acd-4897-a2ee-b98f75ed7aee\_20201203\_174842\_034.jpg, 00:00:32, 2.54 m

Roots, mass at joint, 5% cross-sectional area loss: Now removed

Roots, mass at joint, 5% cross-sectional area loss, Now removed

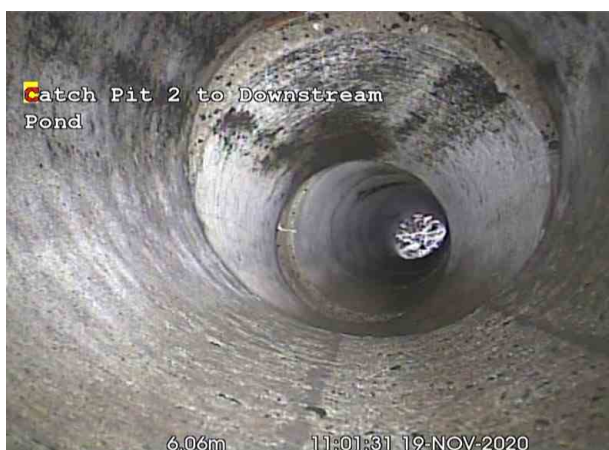
Catchpit  
2X\_1e6a15b3-8ea3-4a8e-96c8-98d016f0abf8\_20201203\_180240\_433.jpg, 00:00:39, 6.06 m  
Joint displaced, medium

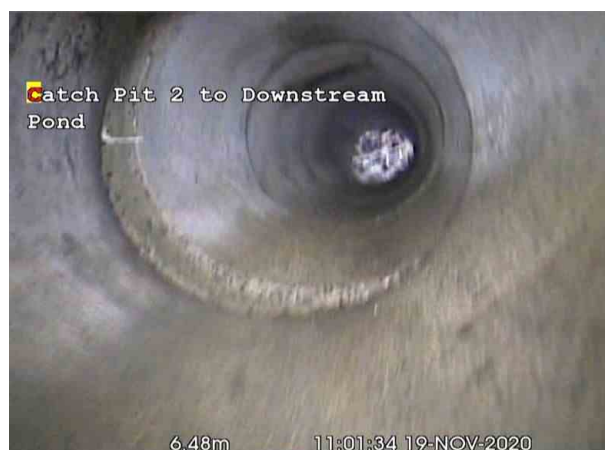
Catchpit  
2X\_2cf8d5a5-e07e-4fe9-9636-ab1e75c9ffee\_20201203\_180311\_721.jpg, 00:00:41, 6.46 m  
Roots, fine at joint, Now removed

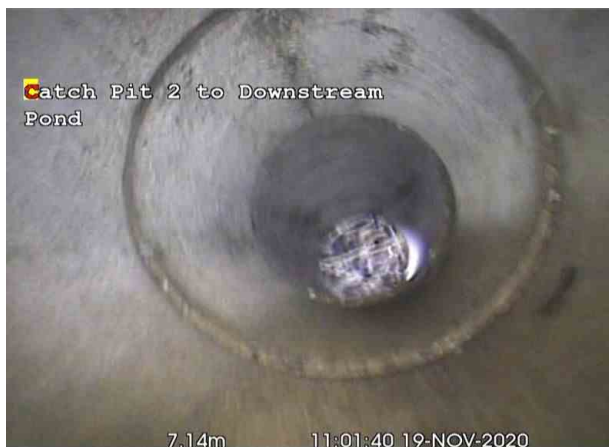
Catchpit  
 2X\_38fb0759-846c-4933-9cb6-24df7fa9f903\_20201203\_18041  
 8\_101.jpg, 00:00:47, 7.14 m  
 Roots, fine at joint, now removed at 3 O'clock

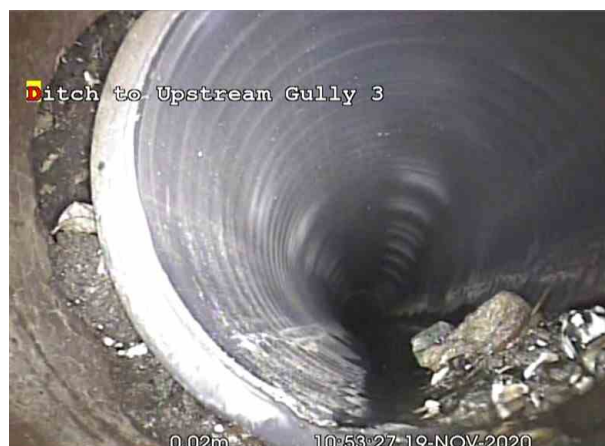
Gully  
3X\_1530199e-b30a-4493-a99d-c0d4d4a7e54d\_20201203\_1808  
04\_848.jpg, 00:00:21, 0.30 m  
Open joint, large, Connection to new Plastic Pipework beneath  
butress

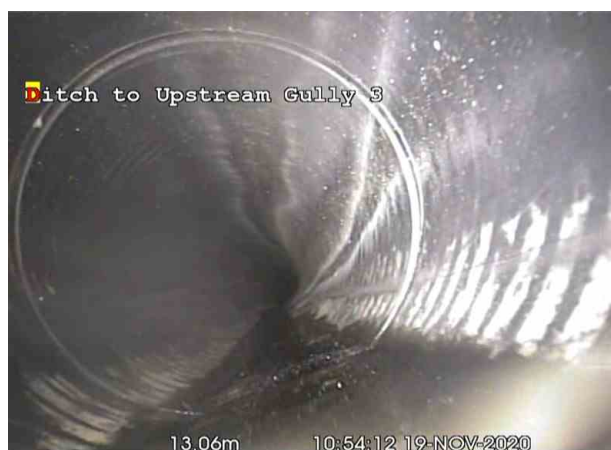
Gully  
3X\_b17bd446-7536-4938-b64c-62b819c0ced1\_20201203\_181  
008\_685.jpg, 00:01:05, 12.60 m  
Water level, 0% of the vertical dimension, Minimal backfall ends

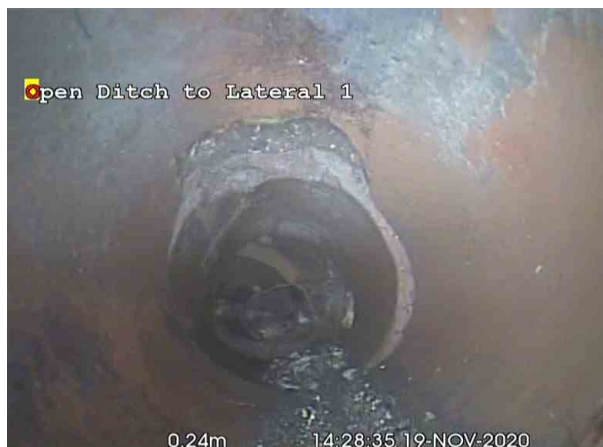
1X\_608f82ee-0ee9-4cbb-9065-db8ff4c53fc5\_20201203\_181419\_754.jpg, 00:00:15, 0.30 m

Hole in drain or sewer from 11 o'clock to 1 o'clock

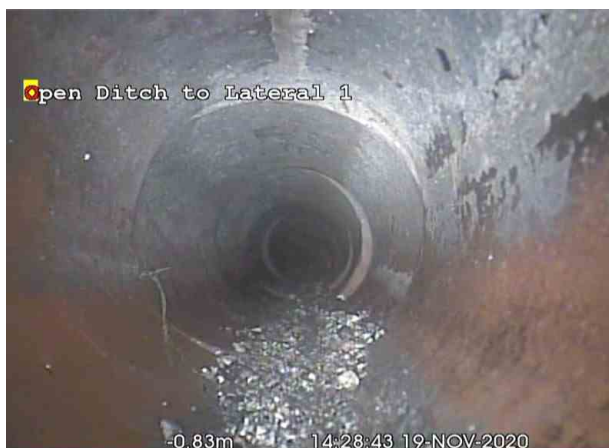
1X\_734973f3-a229-4b7e-a1d0-4b0af2a9c874\_20201203\_181447\_739.jpg, 00:00:23, 0.83 m

Roots, fine at joint

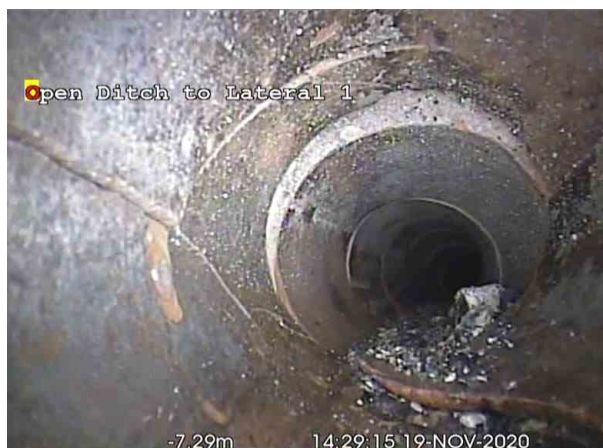
1X\_8a2964a9-bf99-44ea-baba-25ce7f3b0baa\_20201203\_181540\_865.jpg, 00:00:55, 7.20 m

| Scale: | 1:89 | Position [m] | Code | Observation | MPEG | Photo | Grade |
|---|---|---|---|---|---|---|---|
| | | 7.20 | FM | Fractures, multiple from 12 o'clock to 11 o'clock | 00:00:55 | Lateral 1X_8a2964a9-bf99-4 | 4 / 2 |

Fractures, multiple from 12 o'clock to 11 o'clock

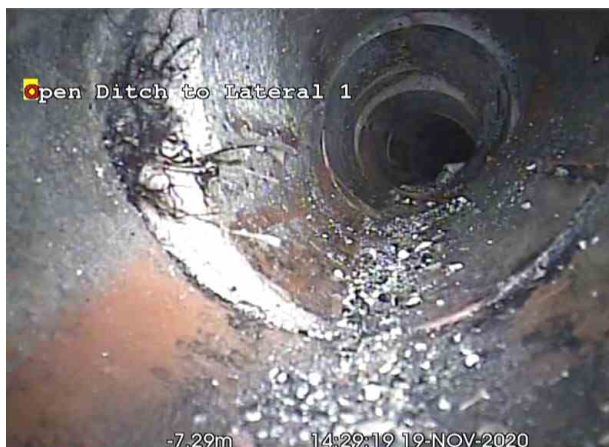
Lateral  
1X\_714e6d18-816b-48bf-acfa-264bb8090927\_20201203\_1816  
06\_828.jpg, 00:00:59, 7.30 m  
Roots, mass at joint, 5% cross-sectional area loss

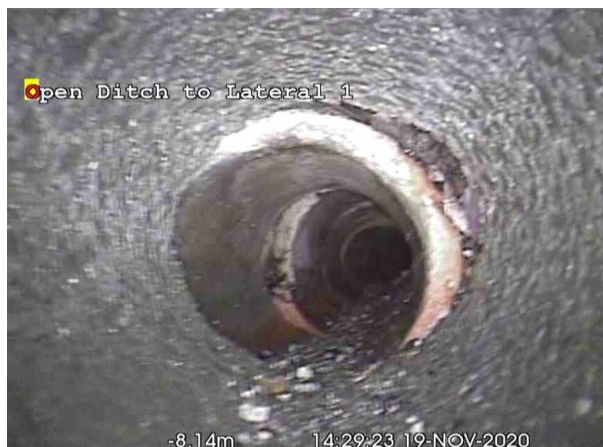
Lateral  
1X\_bc22d3b0-fe0d-4c96-91e1-d211127420da\_20201203\_1816  
38\_603.jpg, 00:01:03, 8.14 m  
Hole in drain or sewer at joint from 12 o'clock to 2 o'clock
