Slindon Village Pond

**Pond condition assessments results and prioritised drainage and
habitat improvement plan for Slindon Parish and South Downs
National Park**

CD Ecology

December 2020

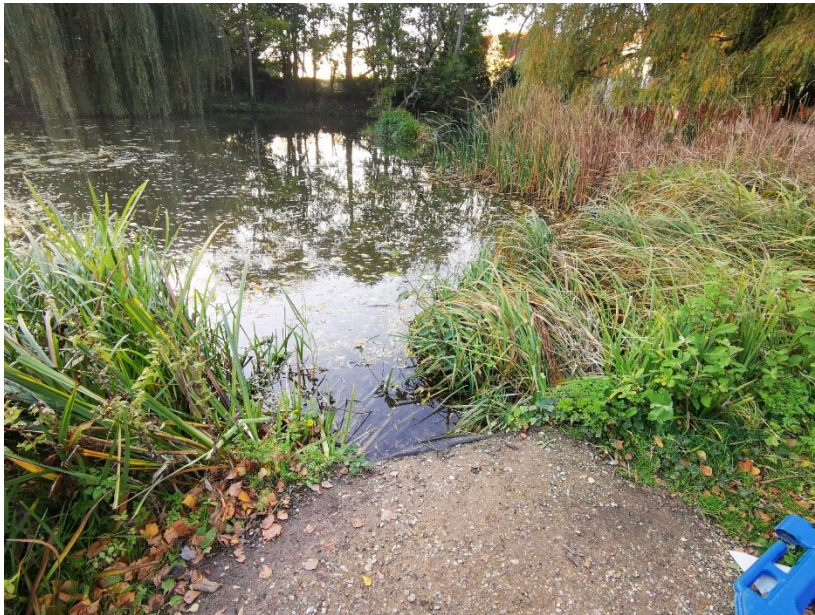
4.1 Survey Reference Point SVP01 (Grid Ref SU96240818)

Water Availability 2/2

Pond Width 4/4

Pond Depth 1/3

Distance from Shore	5m from shore/2ft water	10m from shore/3ft water	15m from shore/4ft water
Silt Depth	0 m	0.2m deep	0.5m deep
Sediment type	Gravel	Gravel/Silt	Silt

Rotational Management both sides together/different timings	0/1
Shading (water >80% shaded = 0 40%-80%=1 <40% = 2)	2/2
Invasive Species	1/1
Total Score	33

Drainage Issues = No

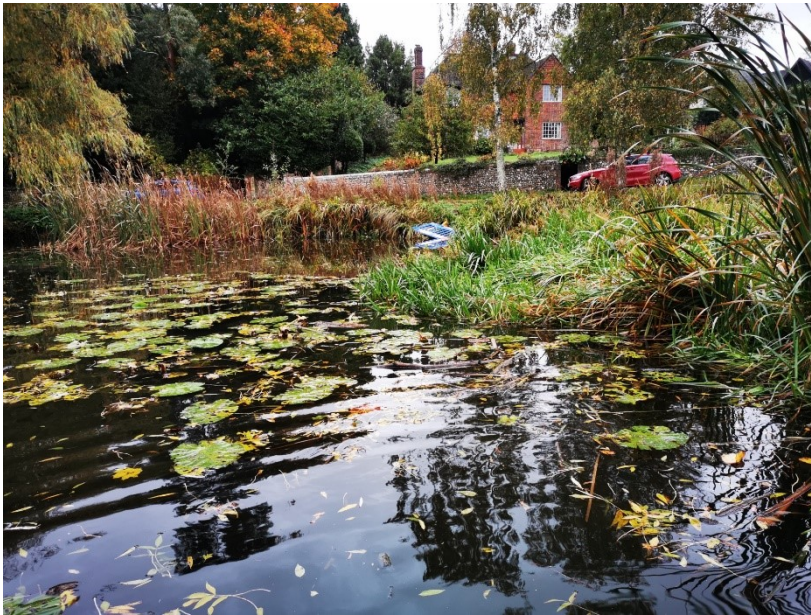
4.2 Survey Reference Point SVP02 (Grid Ref SU96220816)

Water Availability 2/2

Pond Width 4/4

Pond Depth 1/3

Distance from Shore	5m from shore/3ft water	10m from shore/4ft water	15m from shore / 5ft water
Silt Depth	0 m	0.5m deep	0.7m deep
Sediment type	Gravel	Gravel/Silt	Silt

Rotational Management both sides together/different timings	0/1
Shading (water >80% shaded = 0 40%-80%=1 <40% = 2)	1/2
Invasive Species	1/1
Total Score	24

Drainage Issues = No

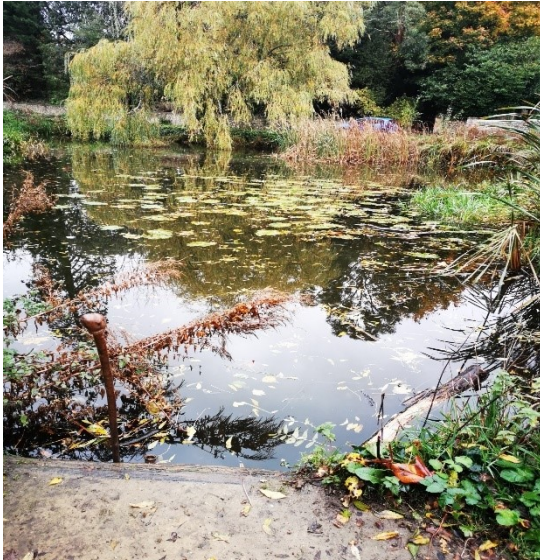
4.3 Survey Reference Point SVP03 (Grid Ref SU96220816)

Distance from Shore	5m from shore/3ft water	10m from shore/4ft water	15m from shore / 5ft water
Silt Depth	0.6 m	1.0 m deep	1.0m deep
Sediment type	Gravel/silt	Silt	Silt

Rotational Management both sides together/different timings	1/1
Shading (water >80% shaded = 0 40%-80%=1 <40% = 2)	0/2
Invasive Species	1/1
Total Score	30

Drainage Issues = Yes (0.1m outlet culvert blocked at the time of survey)

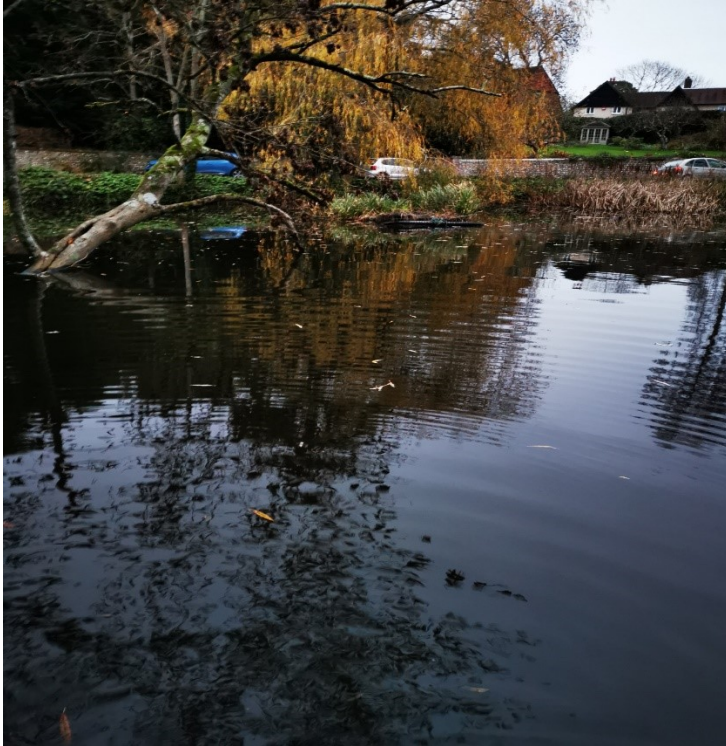
4.4 Survey Reference Point SVP04 (Grid Ref SU96240817)

Water Availability 2/2

Pond Width 4/4

Pond Depth 1/3

Banks Slope 1/2

Bank Structure 1/2

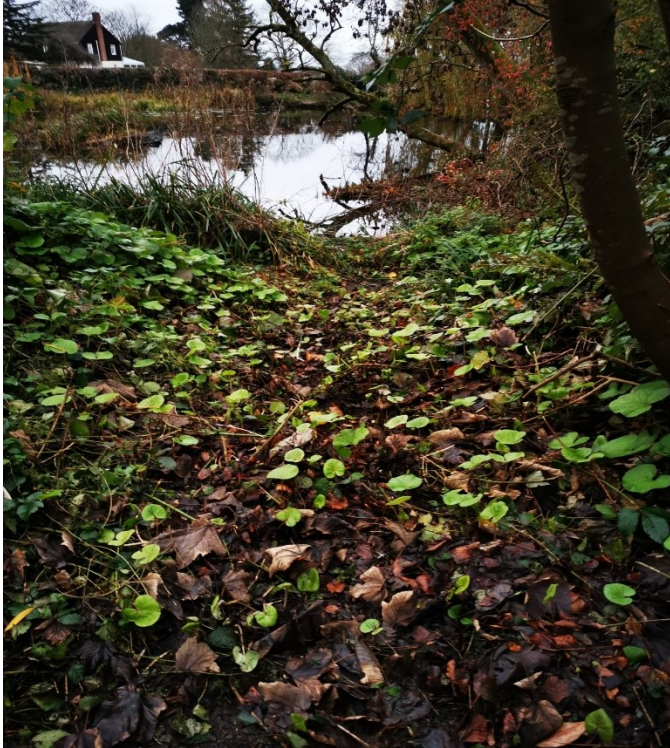
4.5 Survey Reference Point SVP05 (Grid Ref SU96200820)

Pond Width 4/4

Pond Depth 1/3

Connectivity = 1

SVP05 Grid SU96200820	Ref	.Lack of in-channel Vegetation, Silt is deep in the middle of the pond. Remove silt from the centre of the pond. Dig the ditch 3m – 4m and repair the culverts. Create 45 degree angles on the banks to prevent soil spill.	Dig the ditch and remove the silt from the pond. Plant bankside vegetation with riparian plants and wildflower seeds. Use the slit to create small mounds and sow with wildflower seeds. Plant a mix of pollinating trees as described in 8.15. This will improve biodiversity.
SVP06 Grid SU96430820	Ref	+++	New culvert, plant Phragmites near the culvert. This will collect some of the silt and reduce the phosphate and slow the rate of silt deposition.

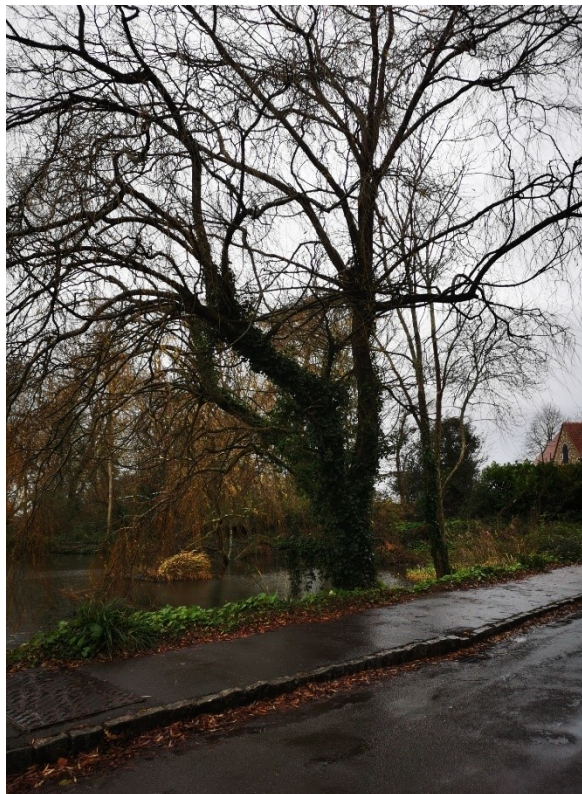
4.6 Survey Reference Point SVP06 (Grid Ref SU96430820)

Pond Width 4/4

Pond Depth 2/3

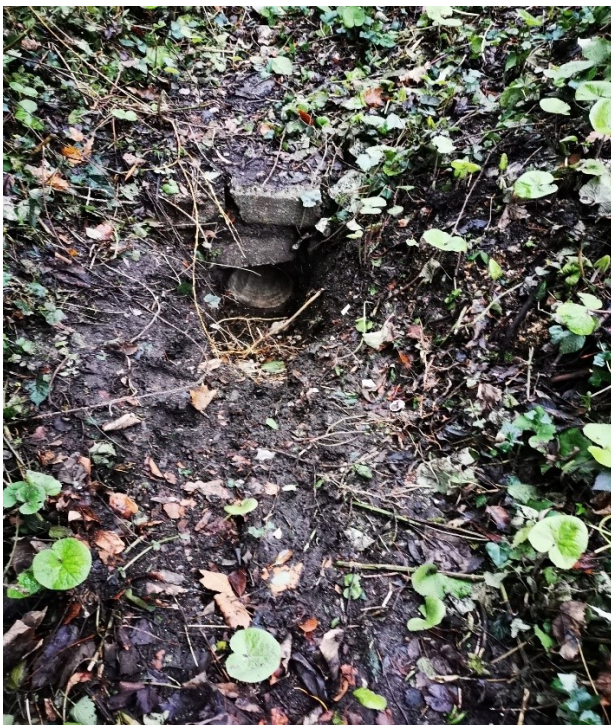
Ditch Survey Reference Point SVP03 (Grid Ref SU96220816) blocked culvert leaving the pond. At the time of survey Christopher checked the pipe and it was blocked.

Ditch Width 0/4 (<0.5m = 0)

Ditch Depth 0/3 (<0.5m = 0)

Total Overall Score	16
0 – 45 = Very Poor, 45-55 = Average, 55 – 65 = Good	Shade, aquatic vegetation, ditch depth and width all will benefit from improvement.

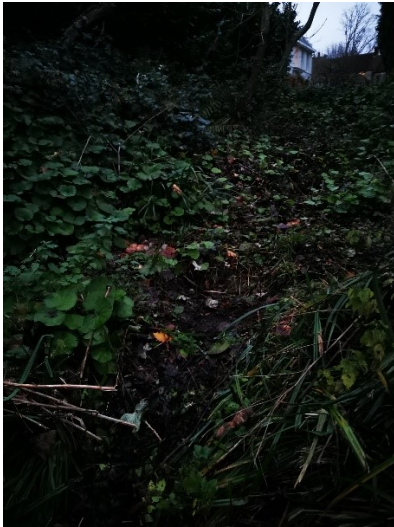
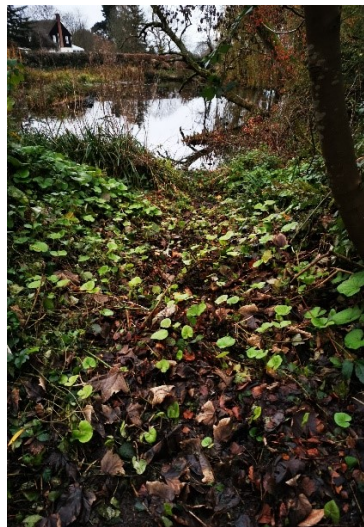
Ditch Survey Reference Point SVP05 (Grid Ref SU96200820) blocked culvert entering the pond. The 0.25m pipe was blocked.

Ditch Width 0/4 (<0.5m = 0)

Ditch Depth 0/3 (<0.5m = 0)

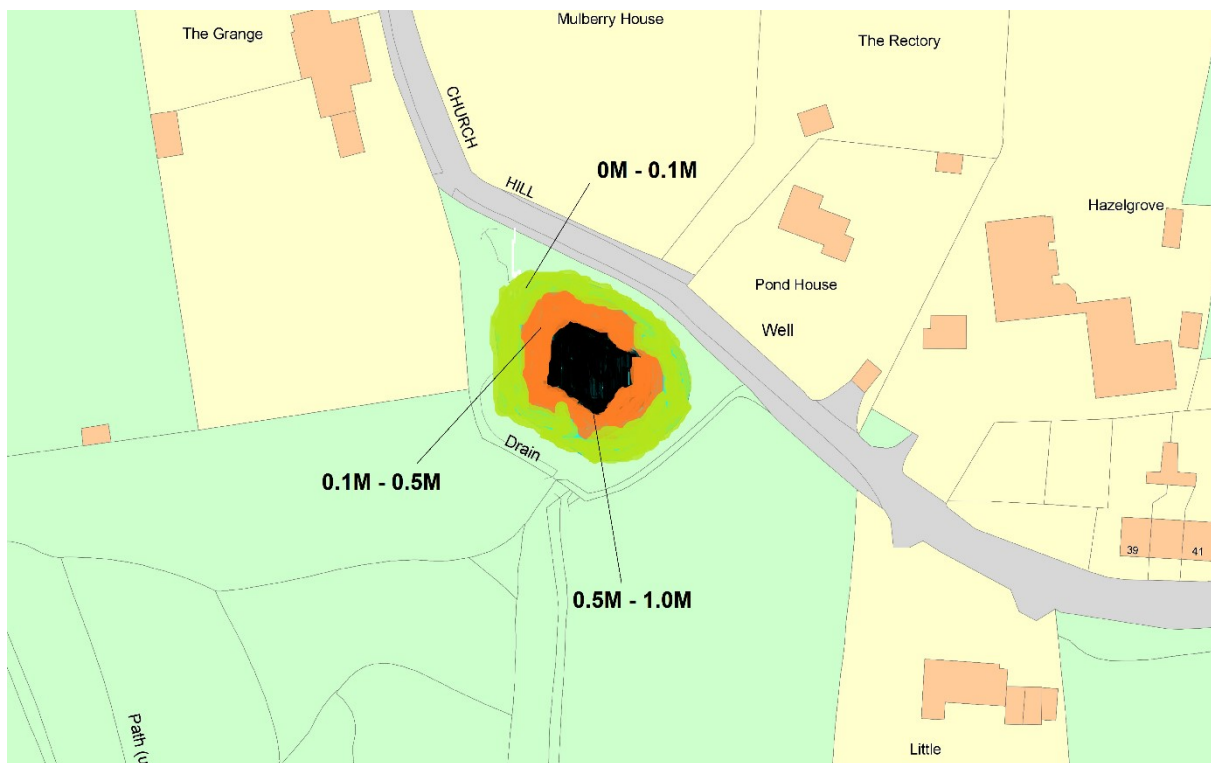
5.31 Sediment/Water Reference Map

During the survey, Christopher recorded gravel and silt making up the topography of the pond. All six reference points have 3 depth reference points on each survey. The silt is predominately dark organic matter which has washed down from nearby areas.

0m – 0.1m Sediment depth = 2/2	0.5m – 1.0m Water Depth = 2/2

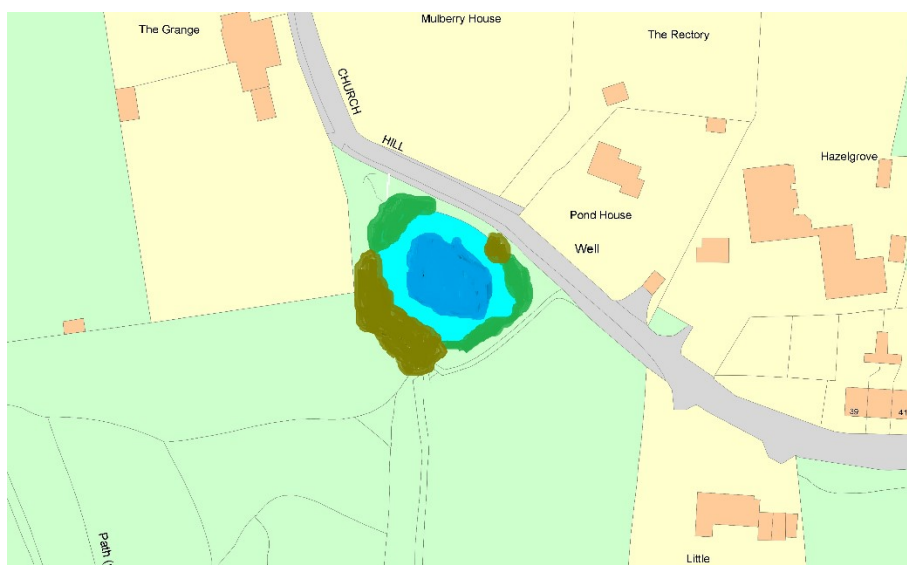
5.41 Current habitat features present

Six sample points were taken to measure plant diversity. Plant diversity has been broken into two categories, Environment and Bankside Vegetation. Map illustration 5.41 identifies the current habitat features around the pond. 100% of the marginal plants are in the sunny sections of the pond and no marginal vegetation was present under the canopy. Moreover, 10% Reed, 65% sedge, 25% Rush and very little Riparian vegetation present around the sunnier sections. A small amount of Water Mint (*Mentha aquatica*) was found near SVP05.

Marginal Vegetation (Reed, Sedge and Rush)
