**Project Name:** Arun DC Slindon Pond Scheme Church Hill Slindon WestSussex

**Project Date:** 03/12/2020

**Inspection Standard:** MSCC5 Sewers & Drainage GB (SRM5 Scoring)

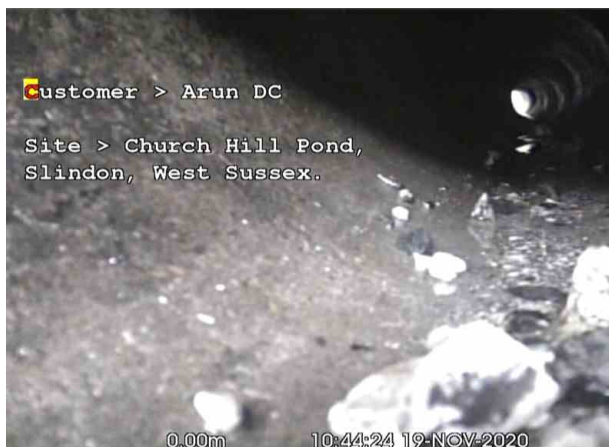
To  
DitchX\_31dbe6d3-3bb8-4160-9800-888573b26841\_20201203\_172305\_156.jpg, 00:00:00, 0.00 m  
Start node type, manhole, reference number: SMH 1, Start

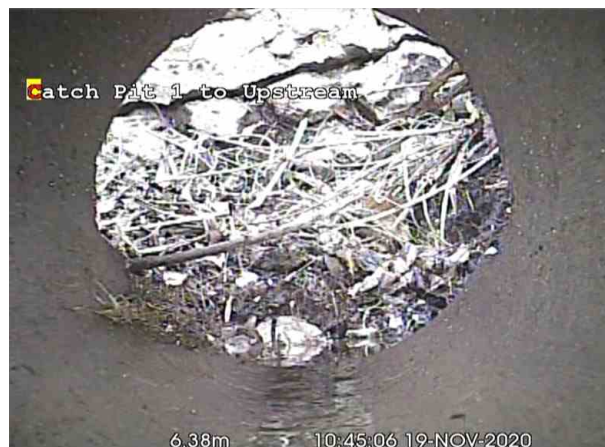
To  
DitchX\_5ea67012-d678-4382-9ce1-a0c4c29ff017\_20201203\_172533\_371.jpg, 00:00:44, 6.36 m  
Finish node type, outfall, reference number: To Ditch, Finish at Ditch

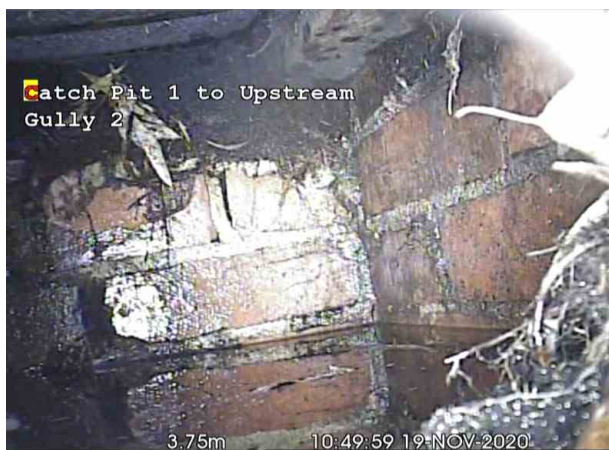
2X\_751b36d9-e64d-4bab-a57e-4a79ee75b865\_20201203\_175828\_834.jpg, 00:00:41, 3.75 m

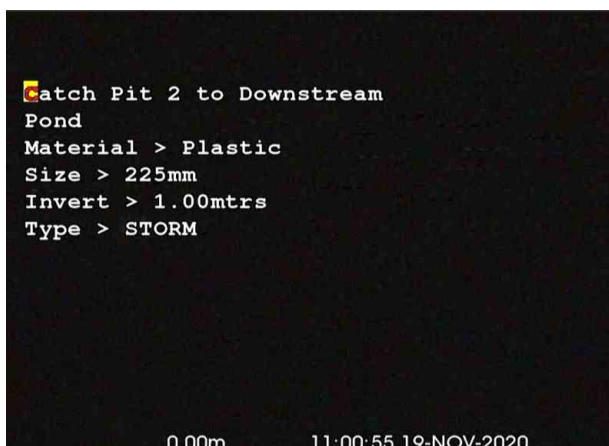
Catchpit  
2X\_18c35186-9409-4687-8fb7-0d47c7fa4017\_20201203\_180035\_320.jpg, 00:00:00, 0.00 m  
Start node type, catchpit, reference number: Catchpit 2, Start

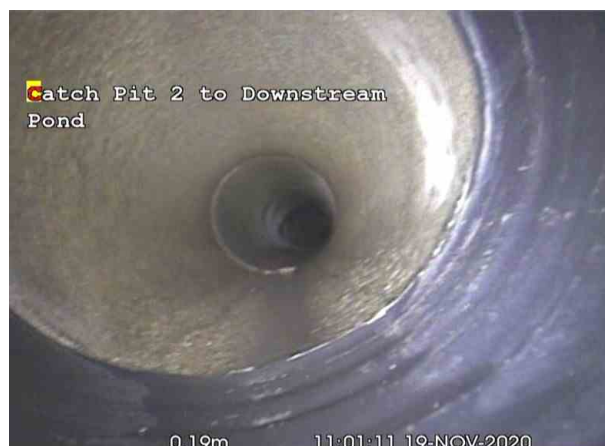
Catchpit  
2X\_937fe937-31ba-4b3a-92a4-ace65b85a166\_20201203\_180129\_645.jpg, 00:00:21, 1.00 m  
Pipe material changes to concrete at this point, Start

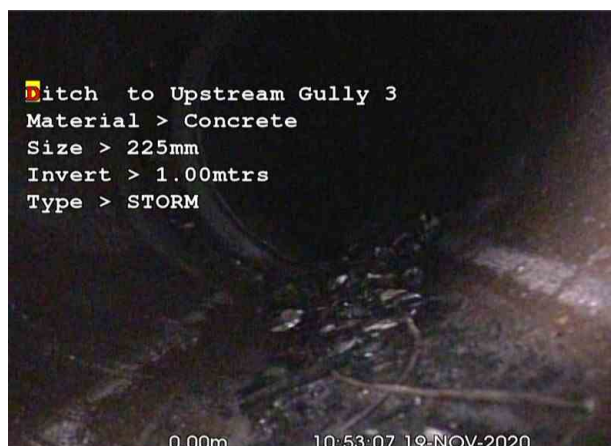
Gully  
3X\_8e46e32b-5771-426a-99e8-3cdcfa6844b2\_20201203\_1807  
00\_686.jpg, 00:00:00, 0.00 m  
Start node type, outfall, reference number: Ditch, Start

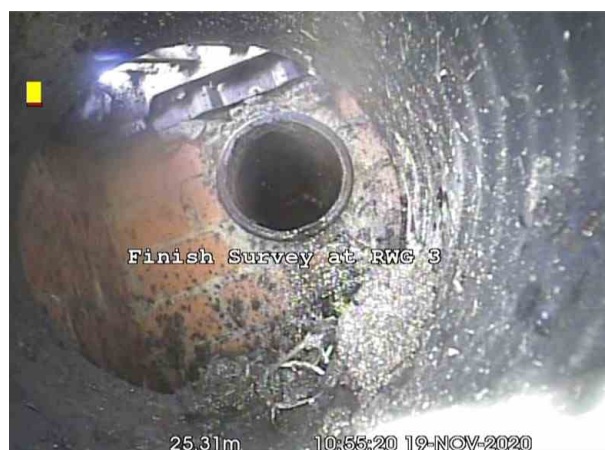
Gully  
3X\_041669d1-2548-4d0f-94cb-b878dbd7c7b9\_20201203\_1811  
36\_021.jpg, 00:02:03, 25.30 m  
Finish node type, gully, reference number: Gully 3, Finish at  
Gully 3

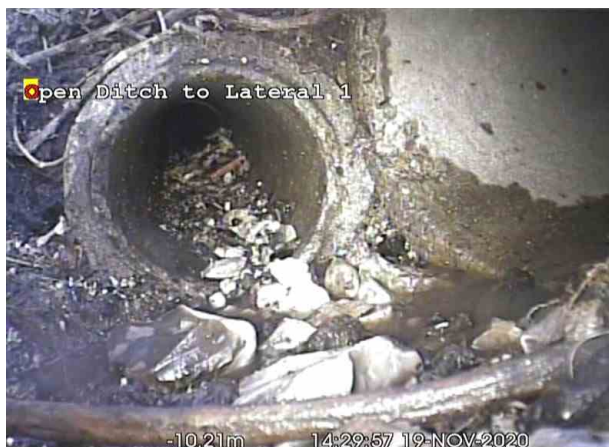
1X\_6c39b302-4ba2-4131-9f91-e4f9d715c00d\_20201203\_181337\_460.jpg, 00:00:00, 0.00 m

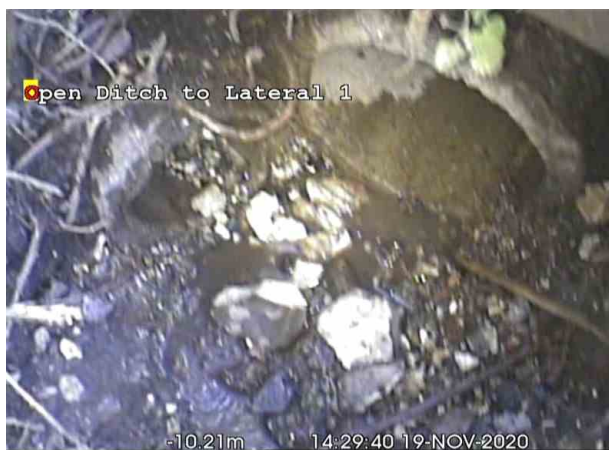
Lateral  
1X\_bf4e8b01-9ddf-4e0b-983c-3207d4c25768\_20201203\_1817  
23\_265.jpg, 00:01:20, 10.20 m  
Finish node type, outfall, reference number: Lateral 1, Finish  
back at Ditch
